NO ROOM FOR A MEDIAN TREATMENT? – THINK AGAIN

ABSTRACT

The aim of this technical note is to provide feedback to the industry on the application and performance of a separation kerb and flexible post treatment installed on double yellow lines on a narrow four lane carriageway, in order to restrict right turning movements from a side road. This was the first application of this treatment for this purpose in New Zealand. The particular product installed was the Saferoads Separation Kerb with Snaploc flexible posts.

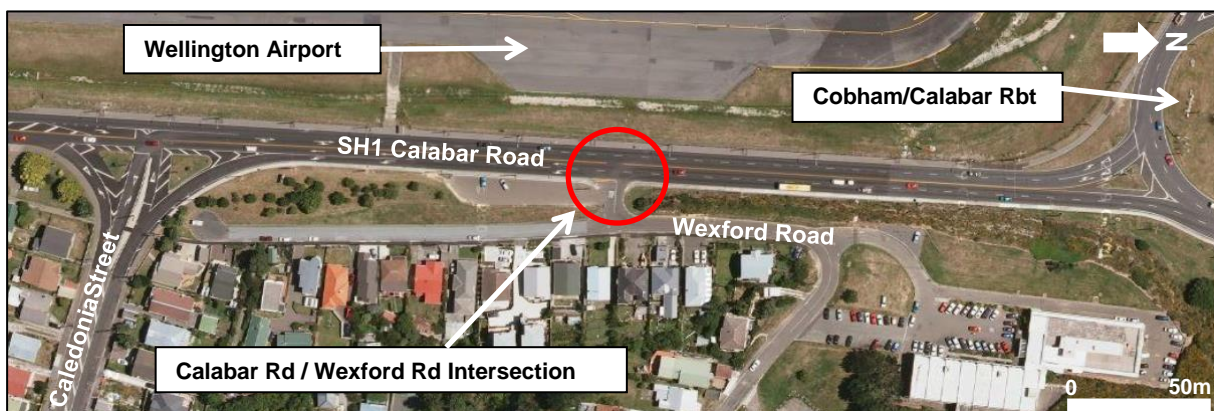
The particular section of Calabar Road of interest, as shown in Figure 1, is at the intersection with Wexford Road. Wexford Road is a minor side road located on a crest curve with movements in/out of less than 750 vehicles per day. Other than for residential access, Wexford Road provides access to two viewing areas for planes and commercial premises for Weta Digital. Visibility to the north, for vehicles exiting Wexford Road, is limited by a high bank to 20m from 5m behind the kerb line and 50m from 3m behind the kerb line. These values are well below the minimum safe intersection sight distance (SISD) for a design speed of 65km/h of approximately 125m¹. Visibility to the south is 60m from 5m behind the kerb line and over 200m from 3m behind the kerb line.

Figure 1: Site location

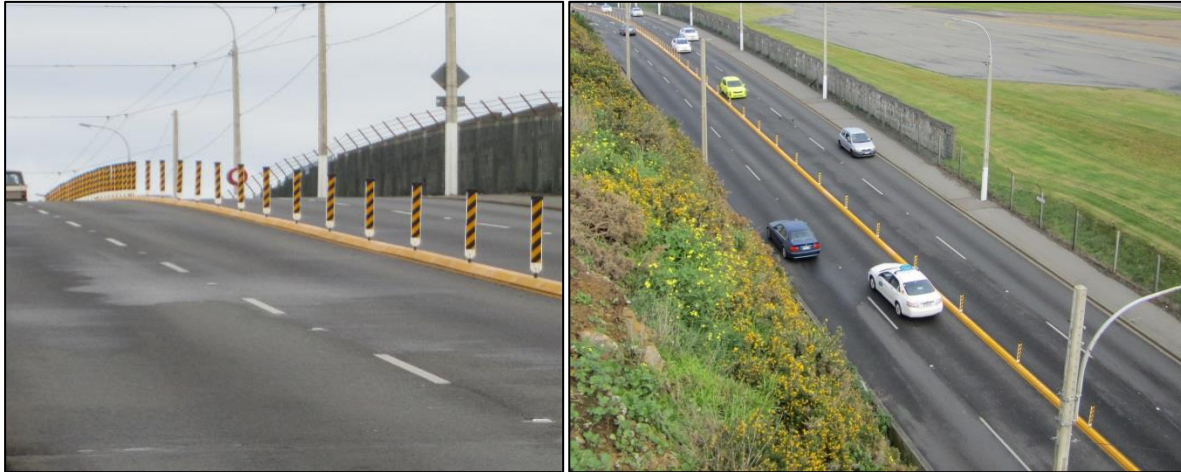
Photos 1 & 2: Separation kerb with flexible posts at completion

Due to the high traffic volumes on Calabar Road installation was required to be undertaken at night which included noise restrictions after 11pm. The noise from the generator and drill were the main concerns and the contractor, Fulton Hogan, worked closely with the Wellington City Council to enable work to occur throughout the night. A noise box was created that moved with construction, reducing the noise to acceptable levels for nearby residents. Installation was completed in six nights, at the end of June 2011, at an average rate of 56 metres per night.
