# SIMPLIFYING STORMWATER ON A COMPLEX SITE

*S. Thompson*

*MWH now part of Stantec*

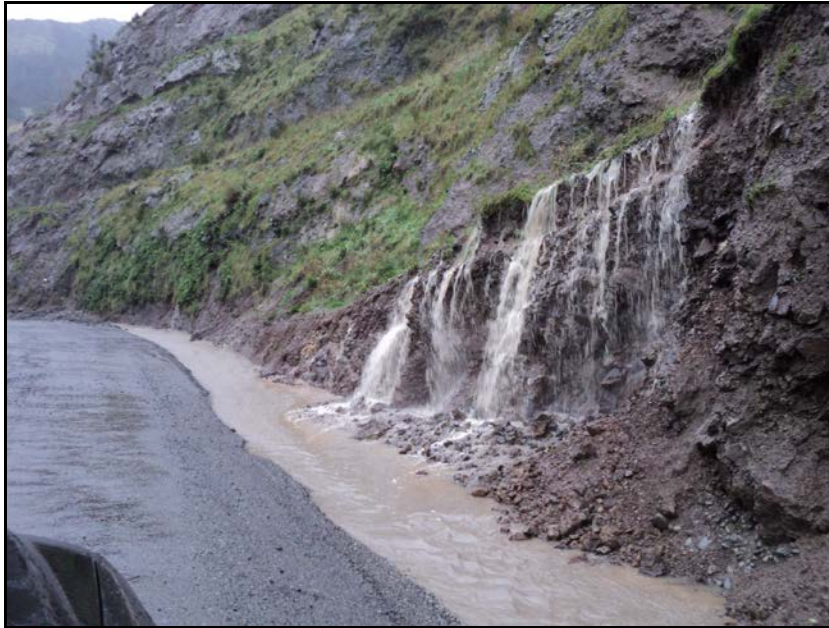
Historically, a significant portion of the runoff from the port hills and Sumner Road collected in the LPC Coal Yard causing ponding and maintenance issues. As can be seen in Photograph 1, this runoff cascaded down the steep catchment, creating subsequent erosion and scour down the hillside.

*Photograph 1: Flooding adjacent to the existing haul road*

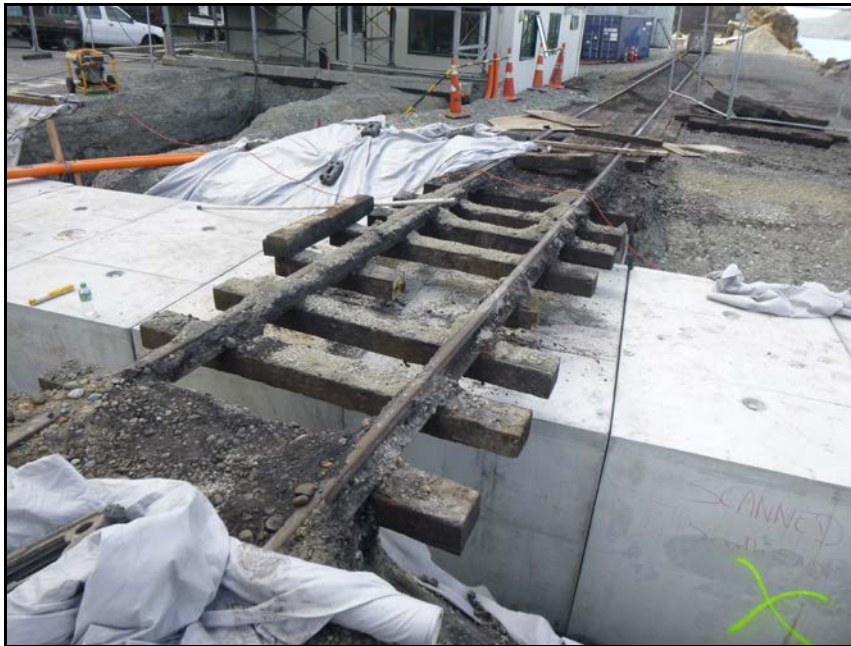
Existing structures and site topography meant the new eastern outfall had to be constructed under the live railway. The final design had to take this into consideration and ensure the outfall could be constructed quickly and easily, ensuring minimal disruption to Kiwirail. Instead of cutting the rail at both ends, construction of the outfall box culvert under the rail was carried out by supporting the rail whilst sliding the culvert underneath.

*Photograph 3: Box culvert crossing under the existing railway*

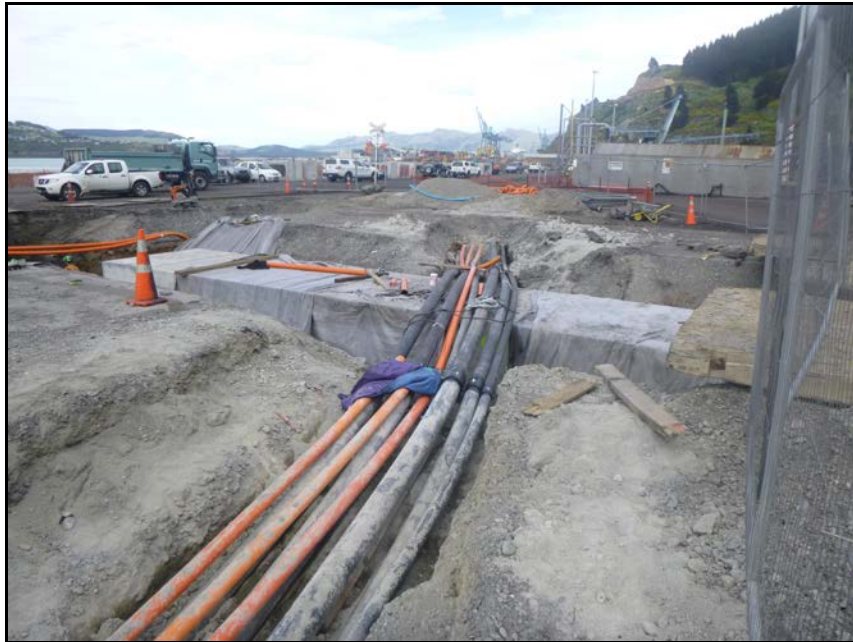
One of the major issues that arose on site was the identification of a number of previously unknown services that clashed with the eastern outfall box culvert. Fortunately, these services were identified through potholing prior to construction commencing, however we had to quickly come up with a solution to either divert the services under, over, through or around the box culvert. We found we could not divert them around the box culvert as the hillside came right up the inlet structure and the other side of the culvert was the ocean outfall. We considered going under or through the box culvert but these options were dismissed due to operational and hydraulic impacts. Therefore, we ended up diverting the services up and over the culvert, refer to Photograph 4.

Photograph 4: Re-route of existing services over box culvert

This solution provided minimal cover over the services so a concrete protection slab was laid between the services and the top of the haul road. LPC were happy with this solution as it gave them access to the services for future maintenance and also allowed the contractor to continue on site without significant delays.
